**AD-A144 622**  
**CONNECTICUT RIVER BASIN**  
**WEST HARTFORD, CONNECTICUT**  
**BURNT HILL RESERVOIR DAM**  
**CT 00488**

**PHASE 1 INSPECTION REPORT**  
**NATIONAL DAM INSPECTION PROGRAM**

**DEPARTMENT OF THE ARMY**  
**NEW ENGLAND DIVISION, CORPS OF ENGINEERS**  
**WALTHAM, MASS**  
**MAY, 1981**

Identification No.: CT 00488  
Name of Dam: Burnt Hill Reservoir Dam  
Town: West Hartford  
County and State: Hartford County, Connecticut  
Stream: Trout Brook  
Date of Inspection: November 26, 1980

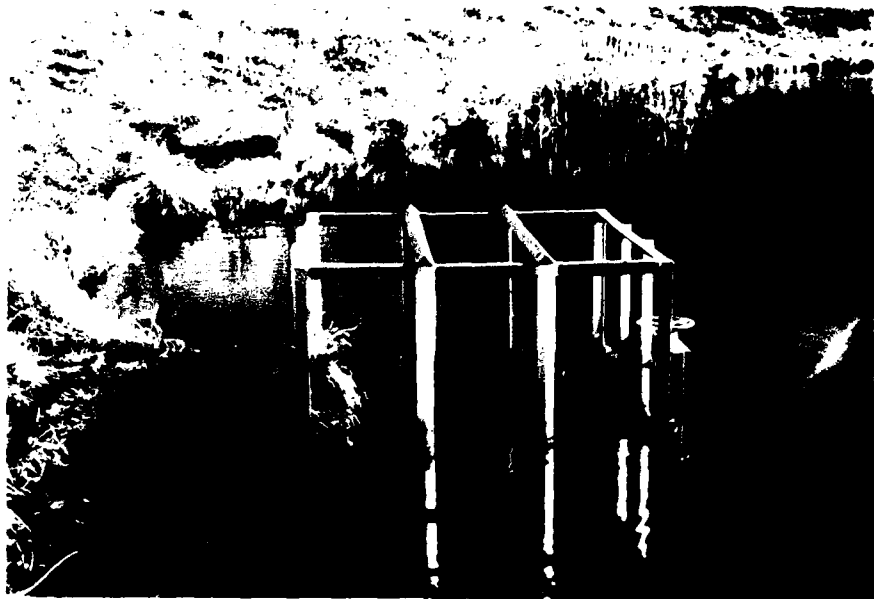
1. Principal spillway: The principal spillway consists of a reinforced concrete riser and an uncontrolled 30 inch RCP extending from the riser to the emergency spillway. These concrete structures are in good condition. The riser is protected by an angle iron trash rack (Photo C-7) which is in good condition. A small operable sluice gate on the riser allows draining of the small sediment pool.

C-7 PRINCIPAL SPILLWAY INLET

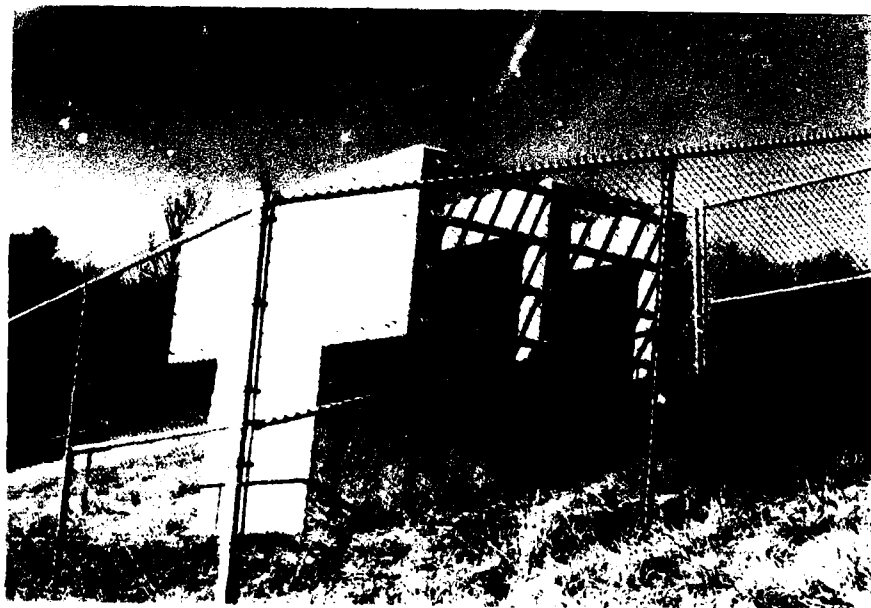
C-8 EMERGENCY SPILLWAY INLET
